# NATIONAL ADVISORY COMMITTEE FOR AERONAUTICS

TECHNICAL NOTE 4132

FATIGUE INVESTIGATION OF FULL-SCALE  
TRANSPORT-AIRPLANE WINGS

VARIABLE-AMPLITUDE TESTS WITH  
A GUST-LOADS SPECTRUM

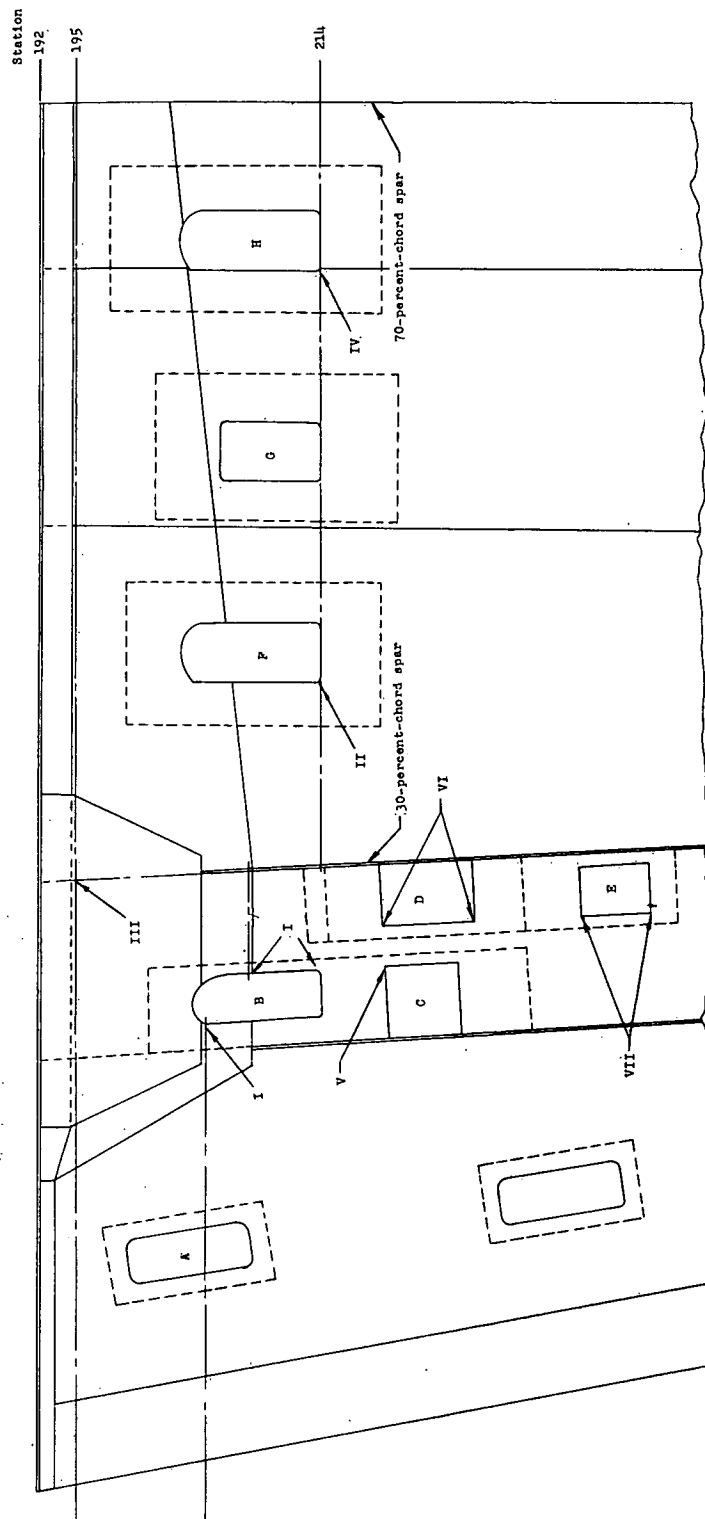
Figure 5.- Details of wing surface. Letters designate inspection cutouts; Roman numerals designate locations at which cracks initiated.

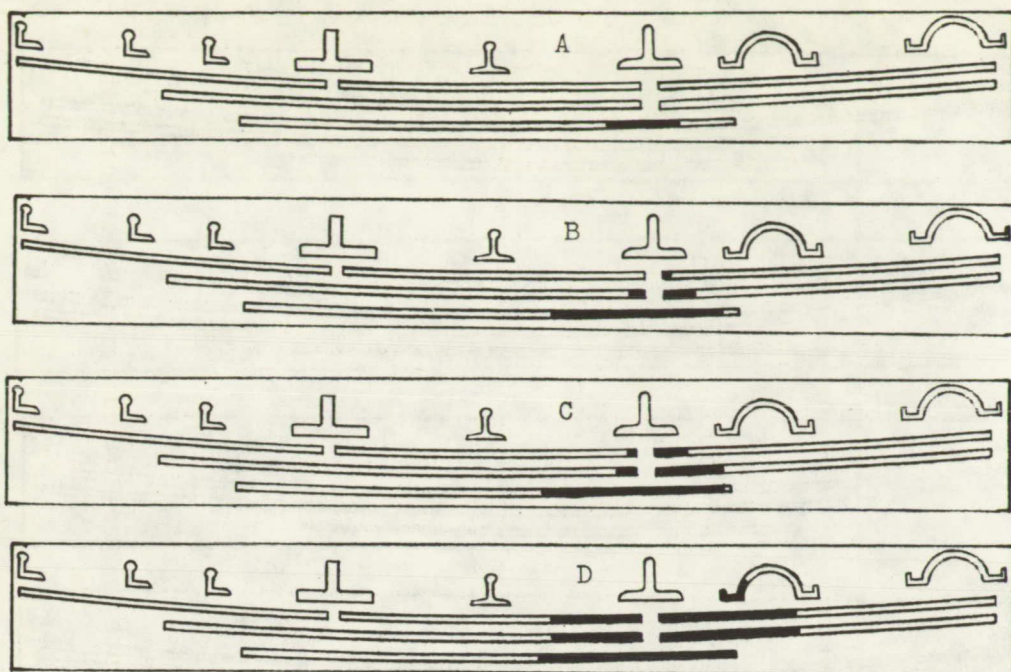
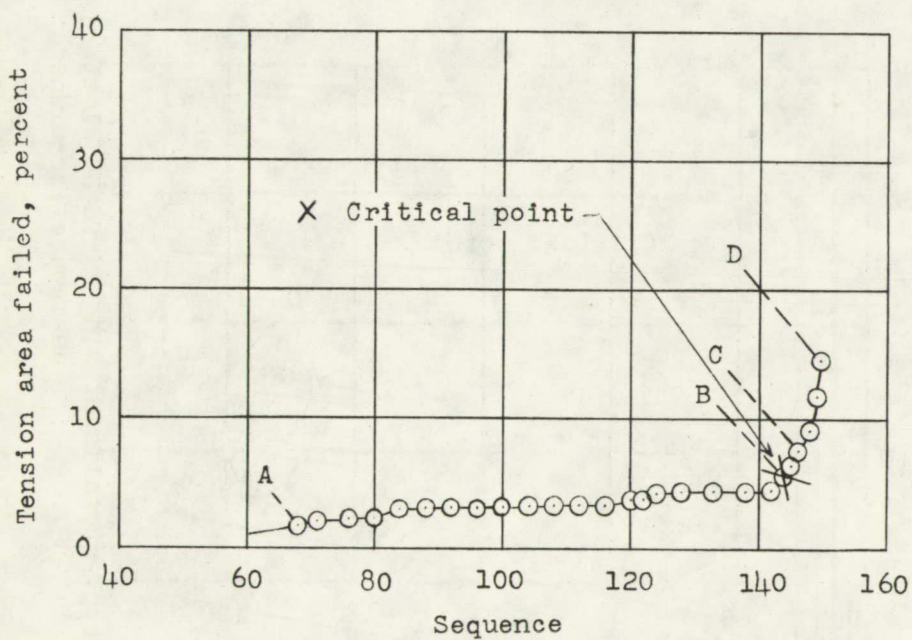
(a) Crack 10; location III.

In each case it can be seen from the curves that the cracks grew slowly until a critical percentage of the material had failed. At this point (defined in ref. 2 as the critical point) the growth of the cracks became very rapid. It can also be seen from figure 6 that the final

Figure 6.- Crack propagation through wings.

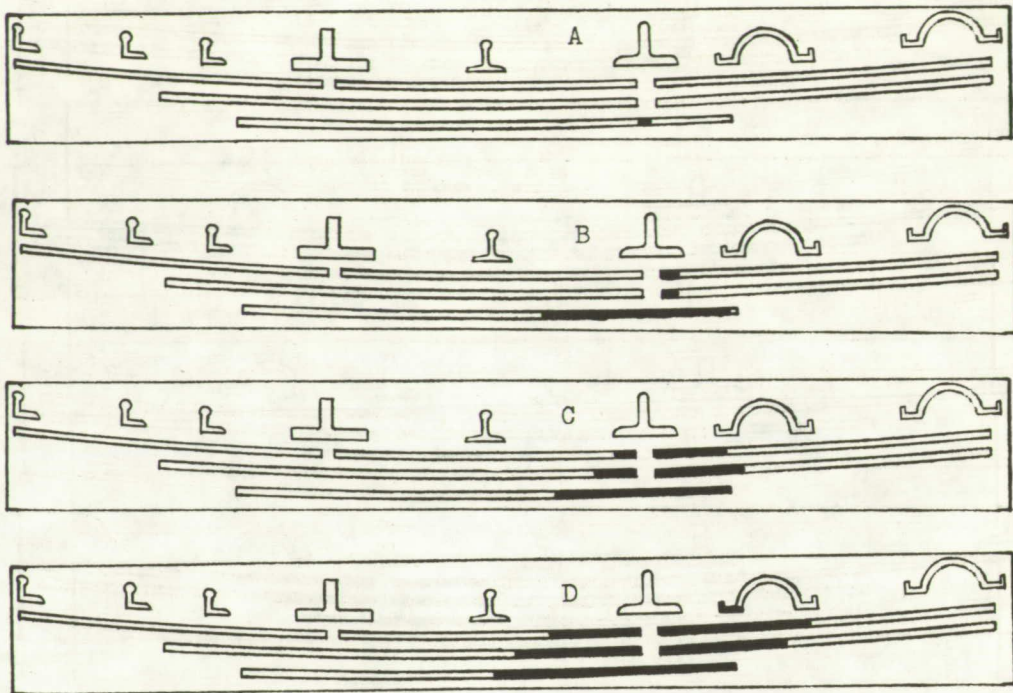
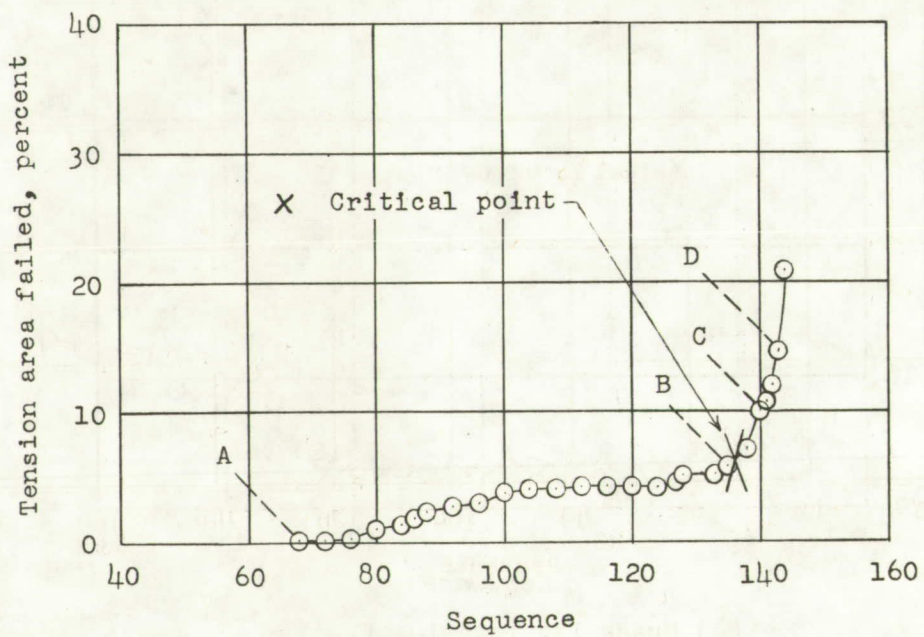
(b) Crack 11; location III.

Figure 6.- Continued.

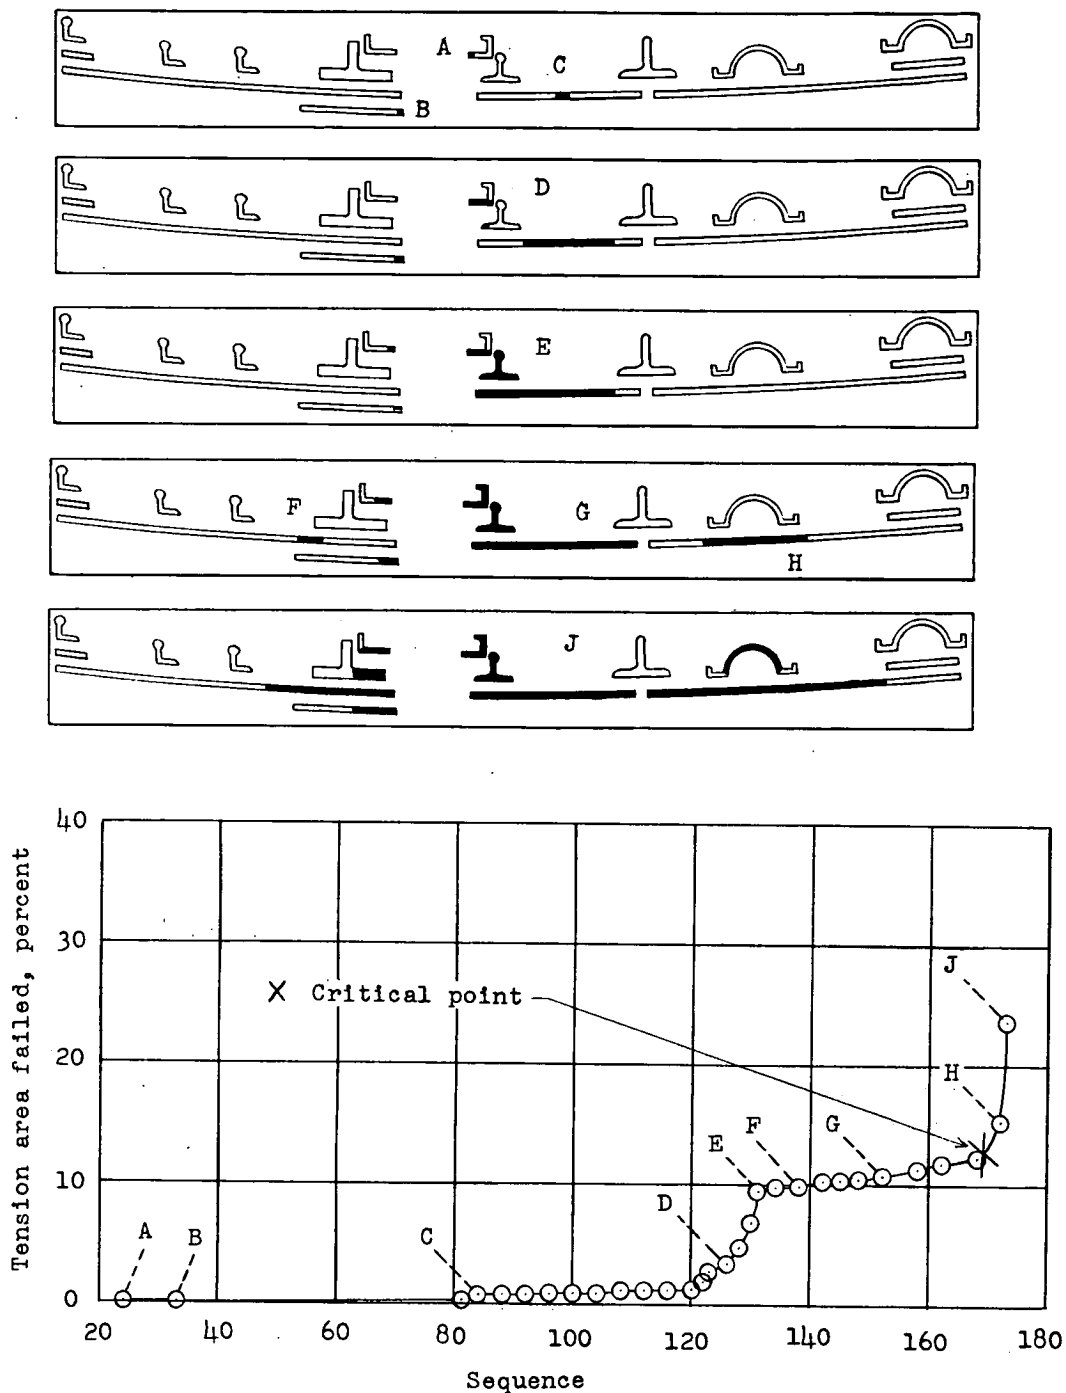
(c) Crack 17; location I.

In most of the wings the cracks that propagated were not the first ones to initiate. On one panel, however, the first crack to appear was the one that propagated to final failure. This was crack 17, in the right outer panel of the second specimen tested. In one other panel the crack that propagated was the last one to initiate in that panel. This was crack 41, in the right outer panel of the third specimen. The spread of the number of cycles to initiation of the cracks which propagated was almost 5 to 1.

The use of X-ray photographs was also required for location I. The progress of a crack in this area can be seen in figure 6(c). The inception of the crack in the heavy T-stiffener forward of the cutout in this area was hidden by the several thicknesses of skin and doubler plates. An X-ray photograph of a crack in this stiffener can be seen in figure 8.

In no case were the wings intentionally loaded to final failure during the fatigue test. The right wing of the second specimen failed completely during the fatigue test at a total load of about 2.90g. Inspection of the failed elements after the test did not reveal the

presence of a larger crack than had been observed prior to the failure and shown in figure 6(c). On the basis of the information in reference 2, this panel failed at a load that was slightly less than the expected failing load.

Figure 6.- Continued.

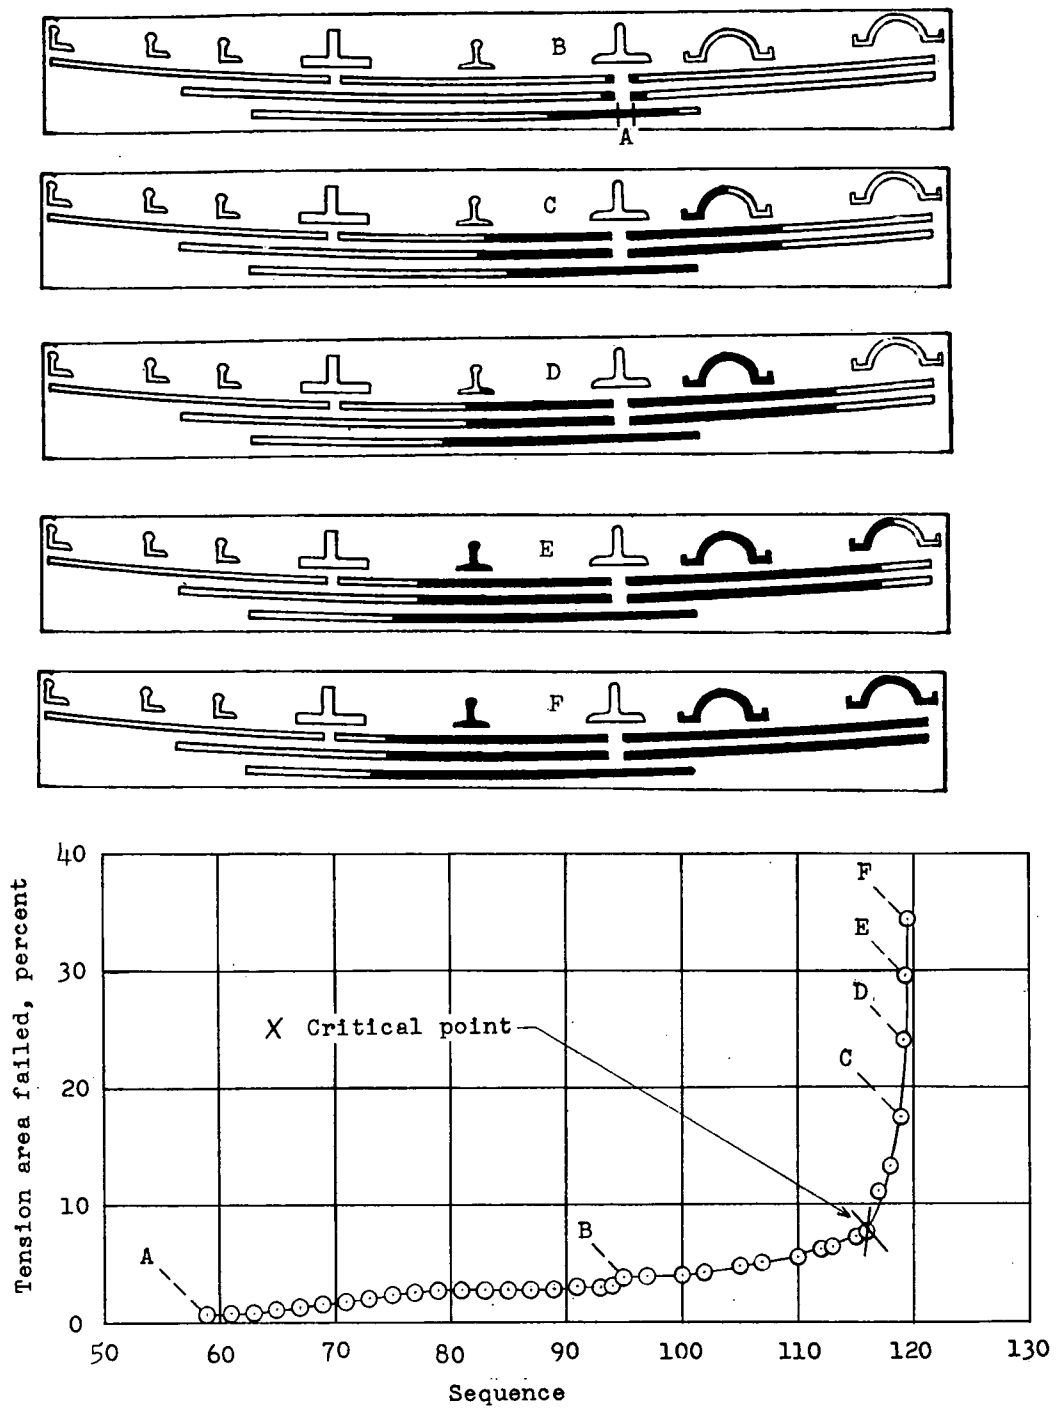
(d) Crack 20; location III.

Figure 6.- Continued.

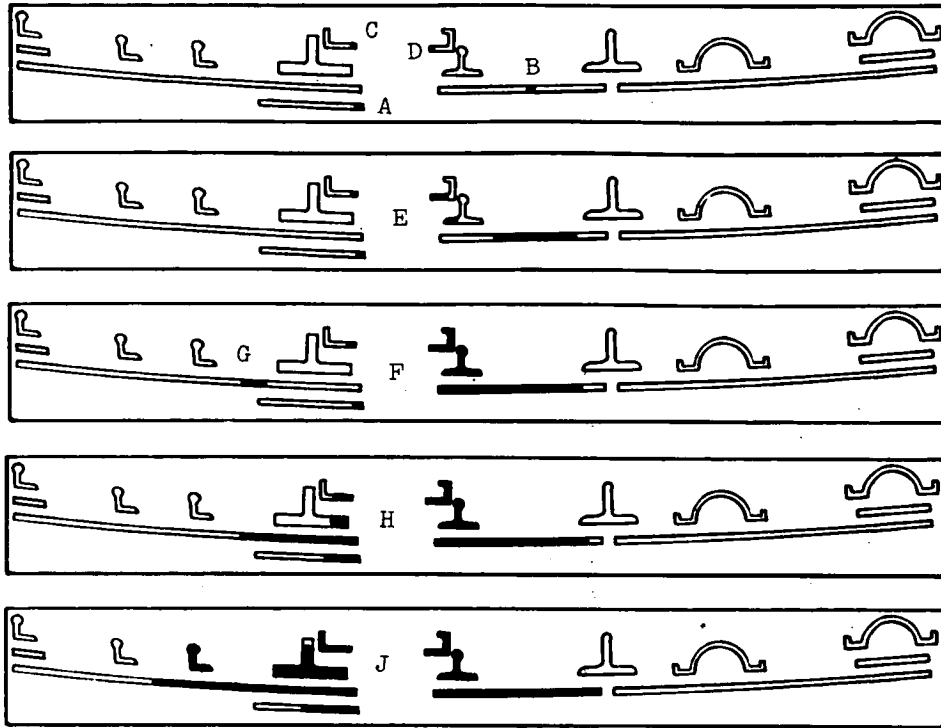
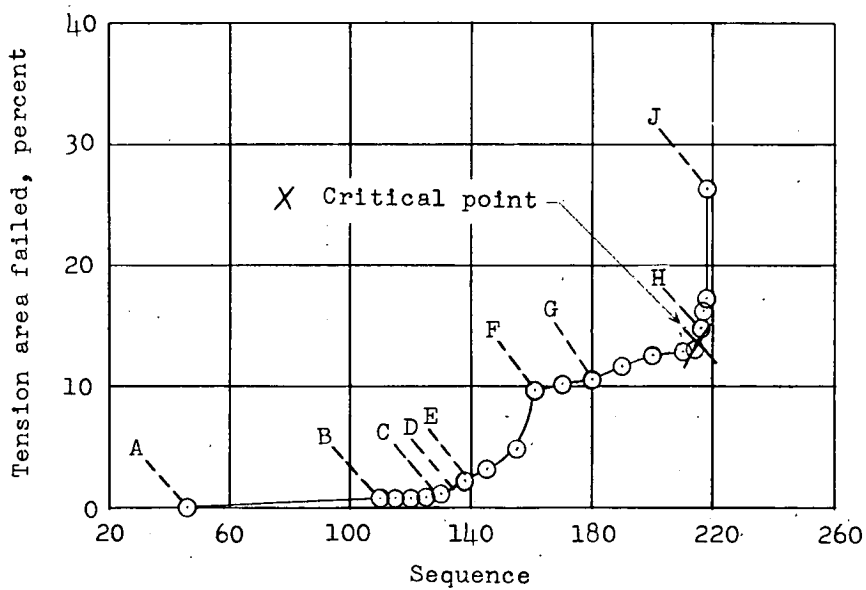
(e) Crack 33; location I.

Figure 6.- Continued.

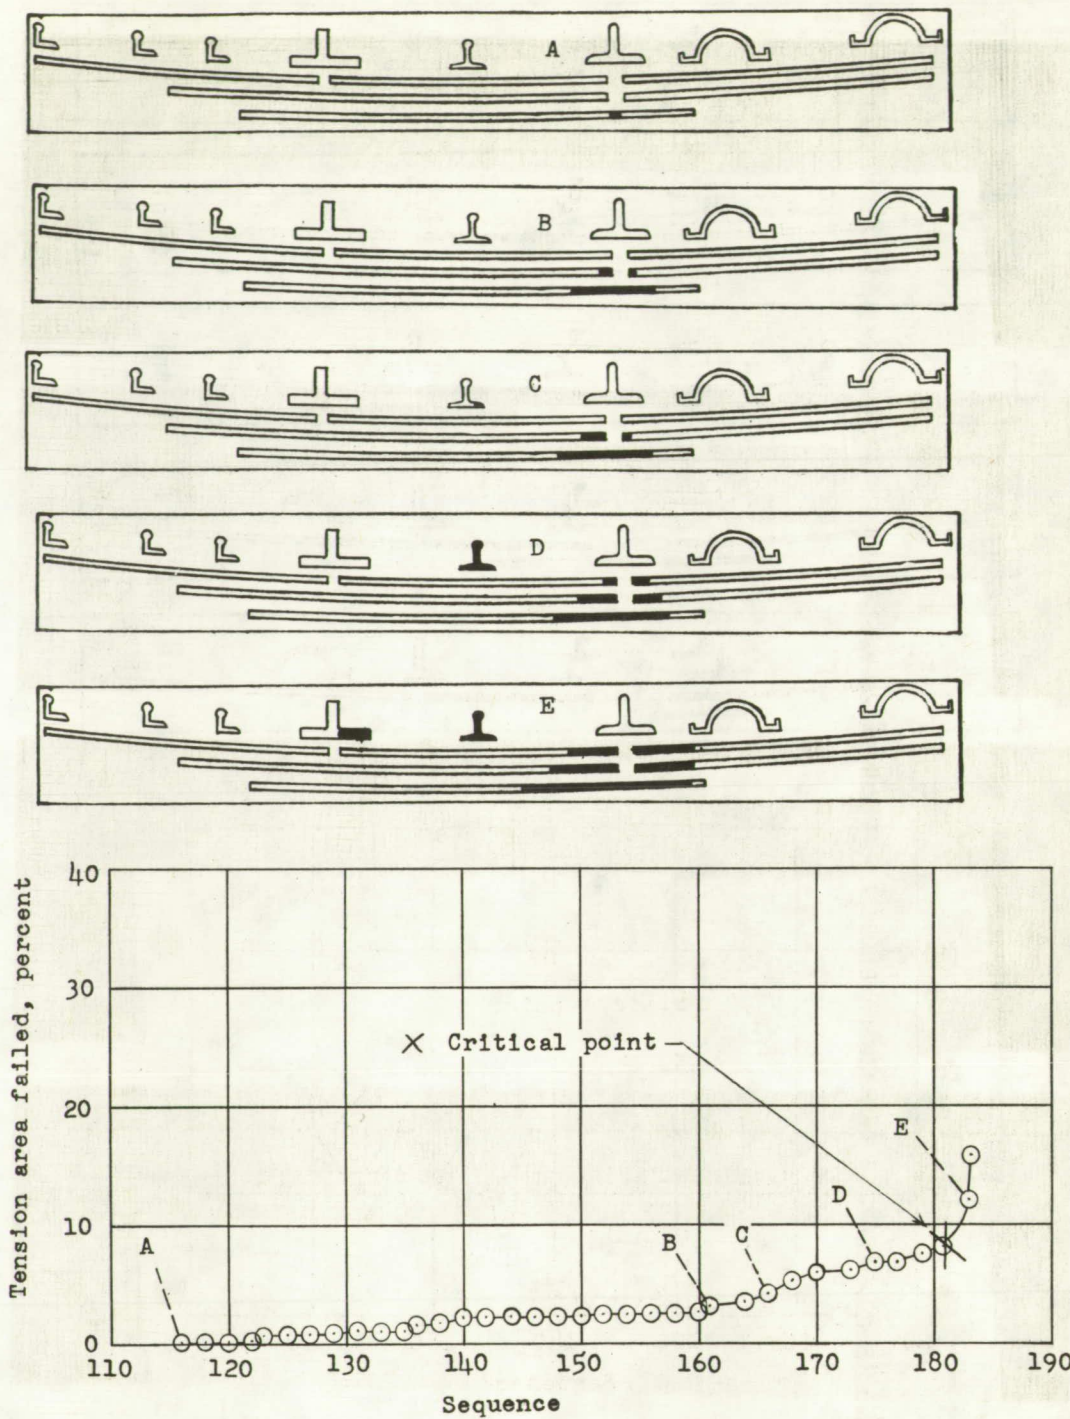
(f) Crack 41; location III.

Figure 6.- Concluded.

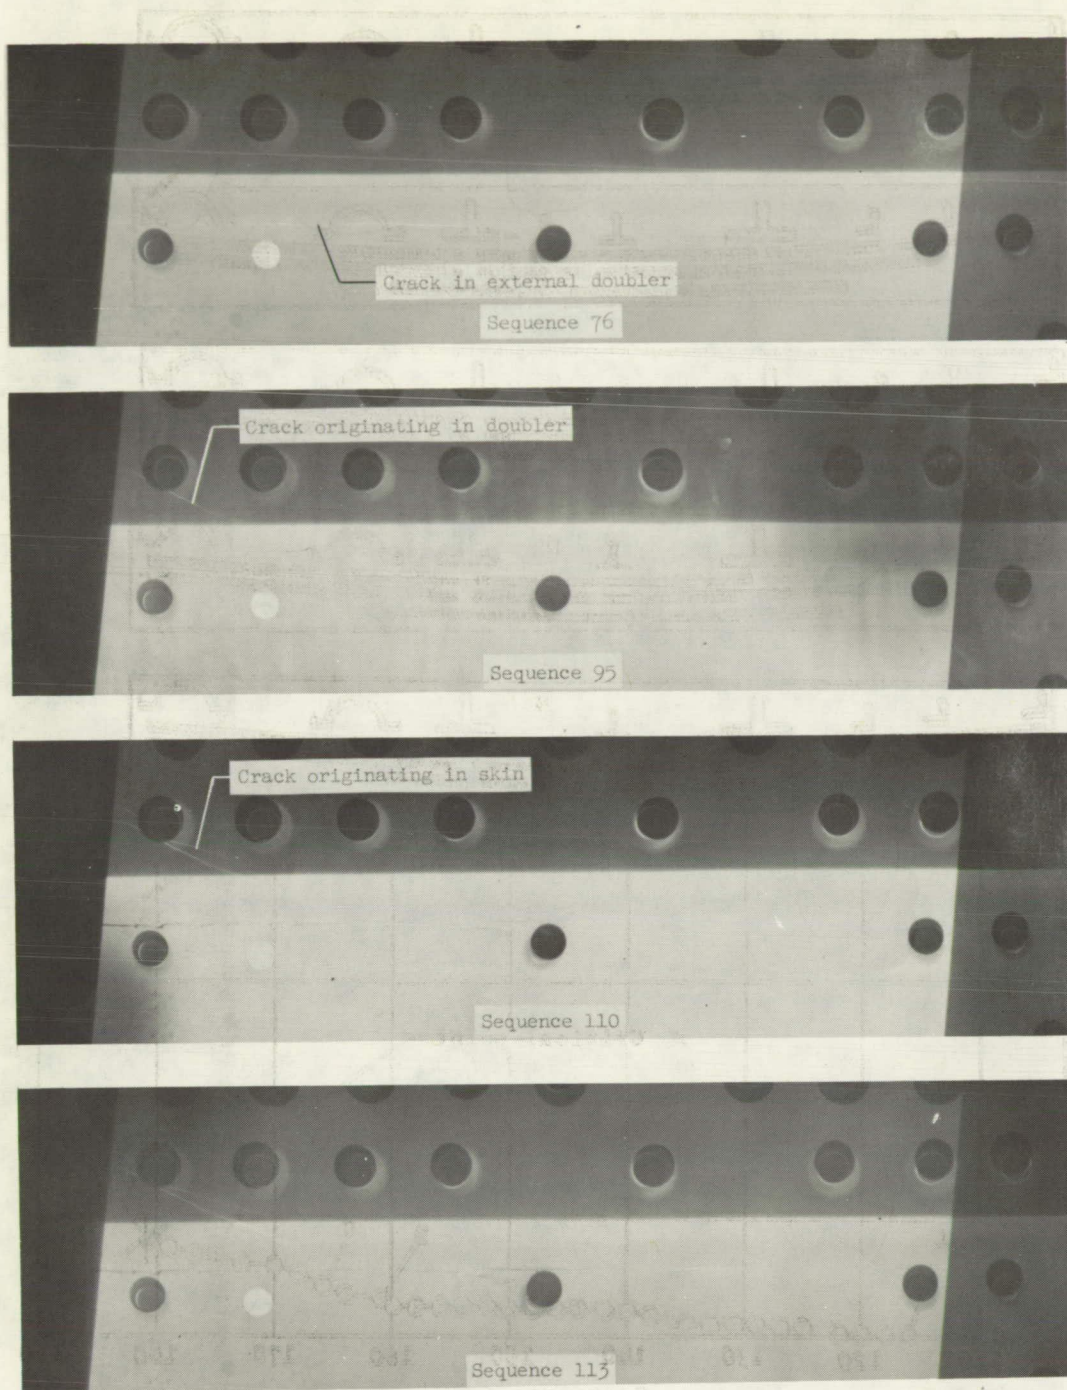
(a) Initial stages.

The X-ray equipment described earlier was used extensively to follow the progress of the cracks through the structure. Location III, which consisted of three thicknesses of sheet material and one leg of the attach angle, was photographed most. The progress of a typical crack in this location can be seen in figure 6(d). The crack was usually detected by a crack-detector wire in the external doubler plate over the 30-percent-chord spar. Periodic X-ray photographs were then made to determine the inception and progress of the crack in the middle doubler plates and the skin. A series of X-ray photographs of this area, showing the progress of the crack forward of the 30-percent-chord spar, can be seen in figure 7.

Figure 7.- X-ray photographs of crack 20 in joggle in external doubler plate.

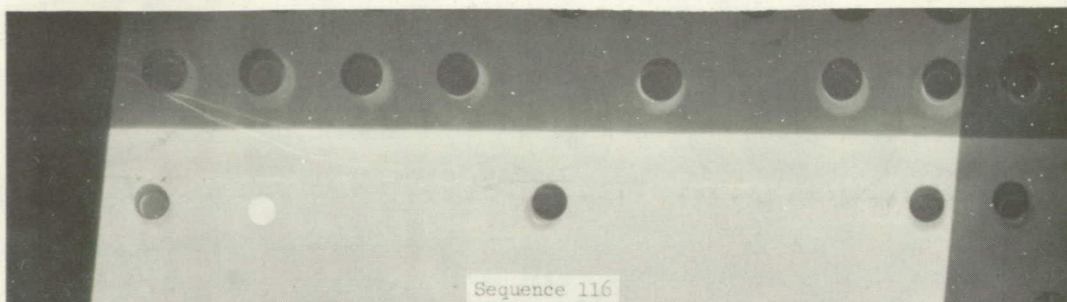
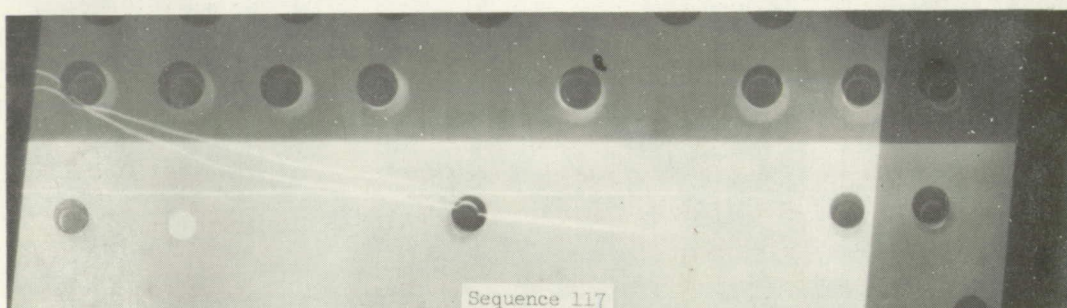
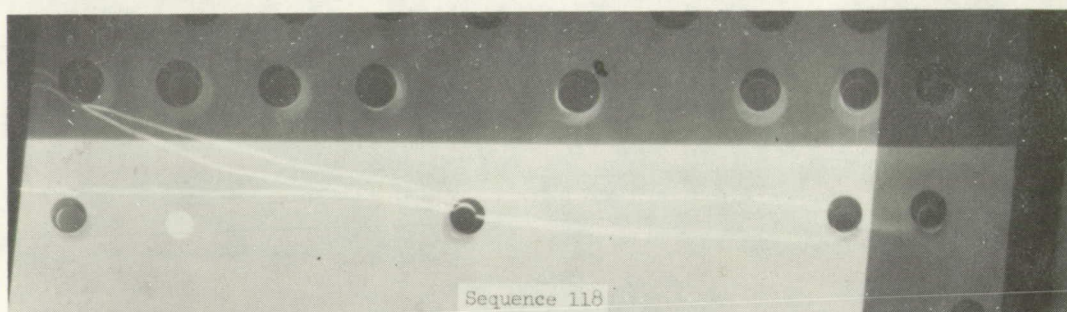
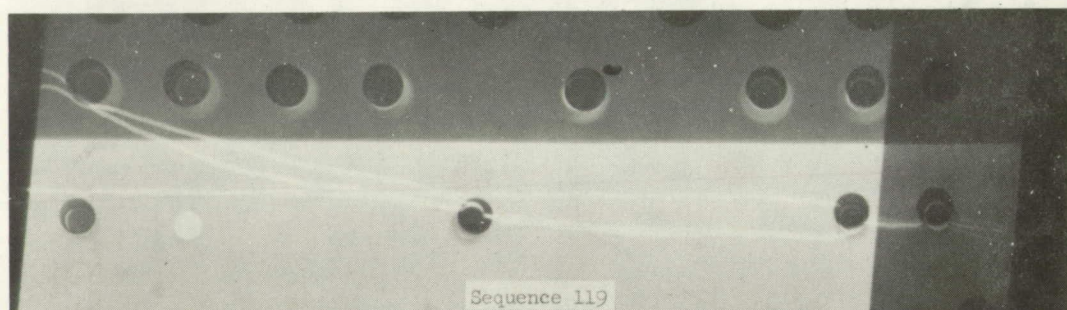
(b) Final stages.

Figure 7.- Concluded.

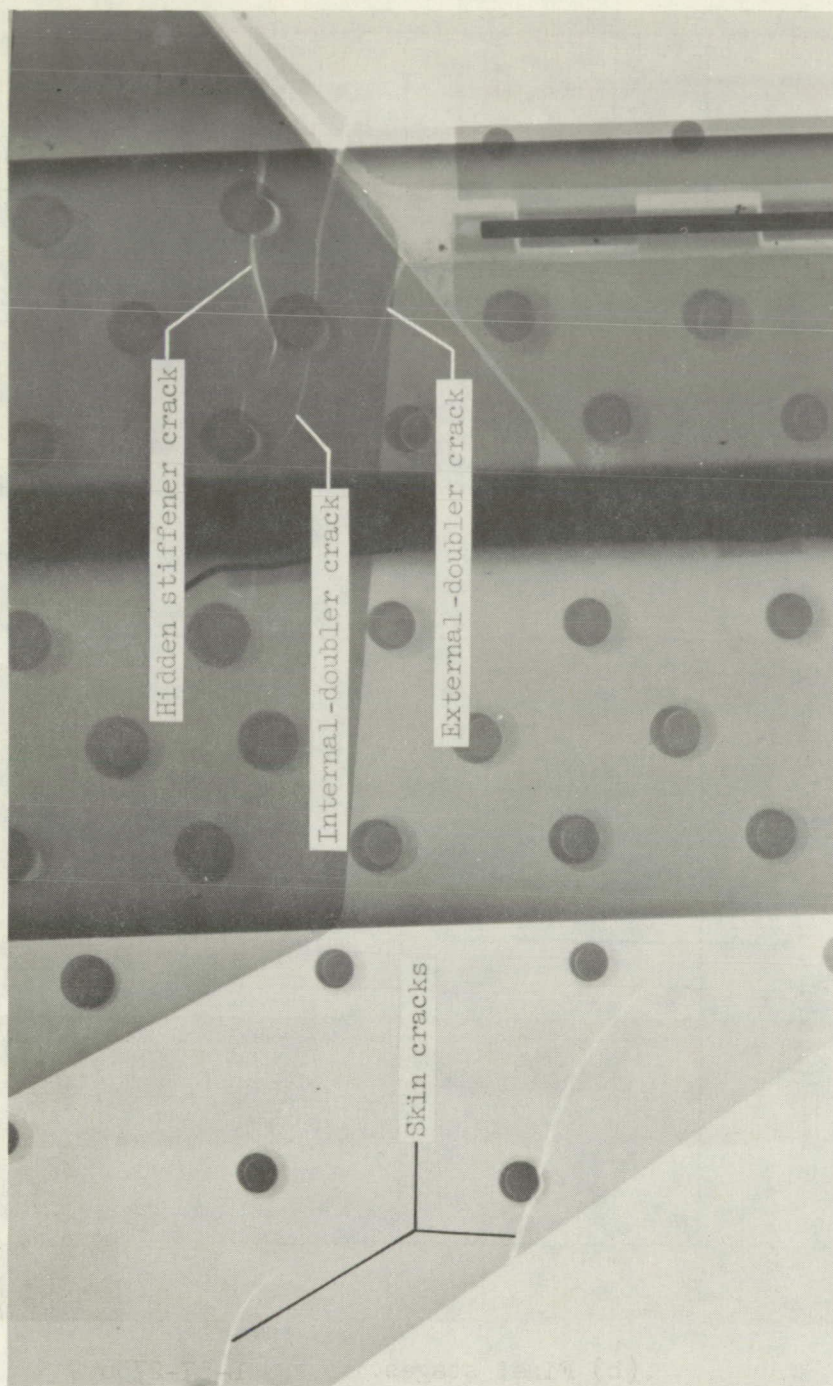
Figure 8.- X-ray photograph of crack in corner of inspection cutout. L-57-2737

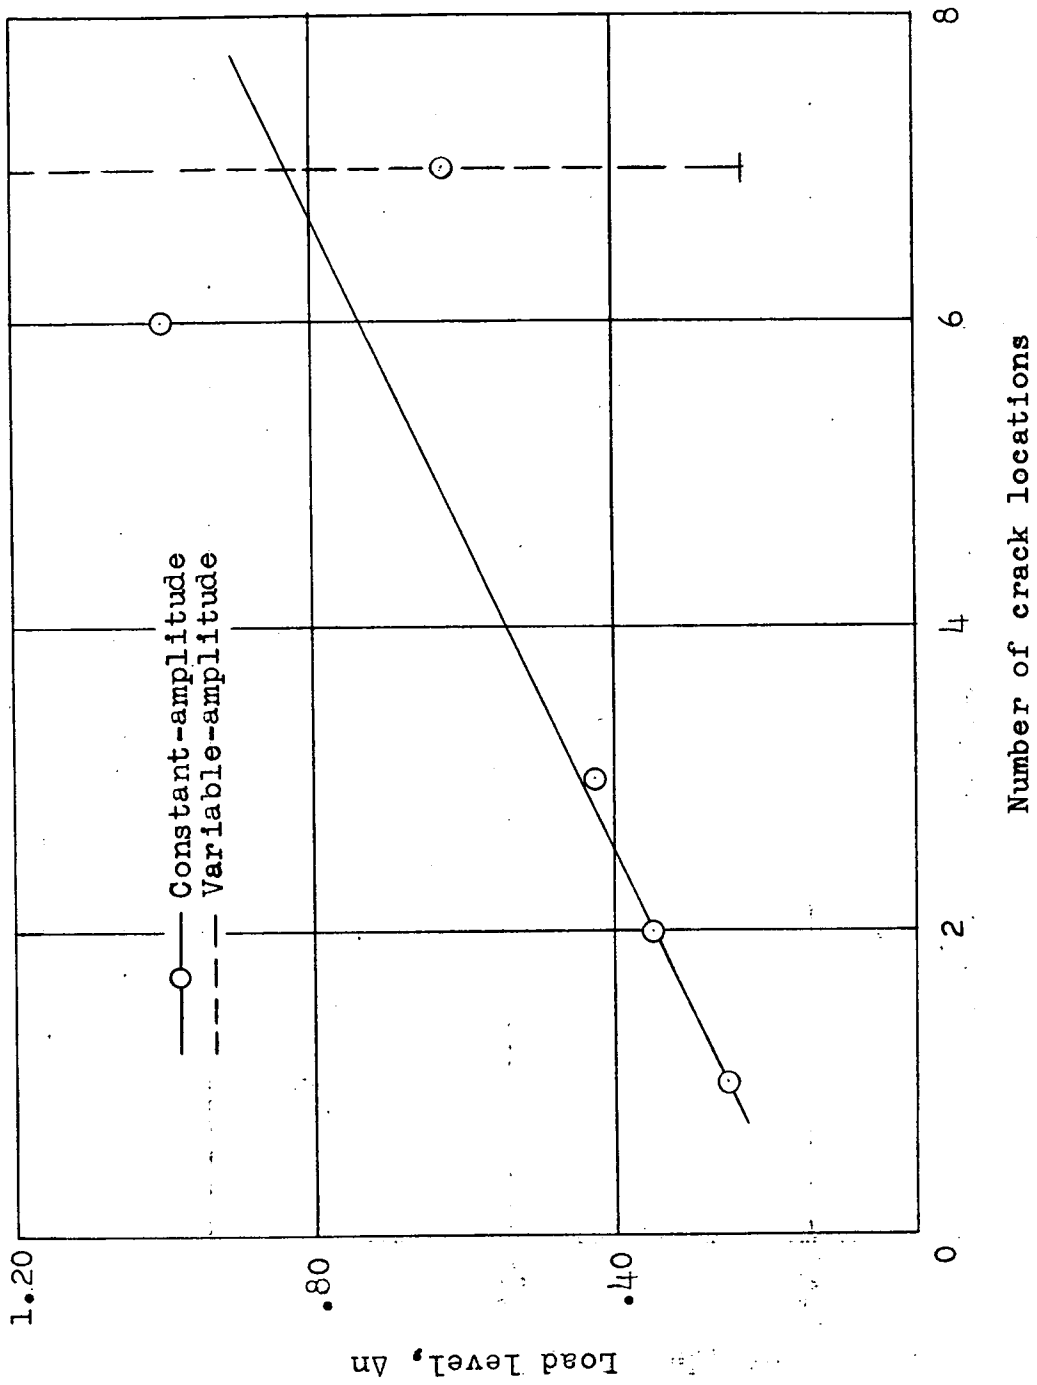
Figure 9.- Frequency of crack locations for constant-amplitude and variable-amplitude tests.

The number of locations at which cracks were observed during these two types of tests are shown in figure 9. The number of locations increased with increasing load level, and there were as many crack locations in the variable-amplitude tests as in any of the constant-amplitude tests. Most of the locations at which cracks were observed during the constant-amplitude tests were repeated during the variable-amplitude tests. There were, however, no new crack locations.

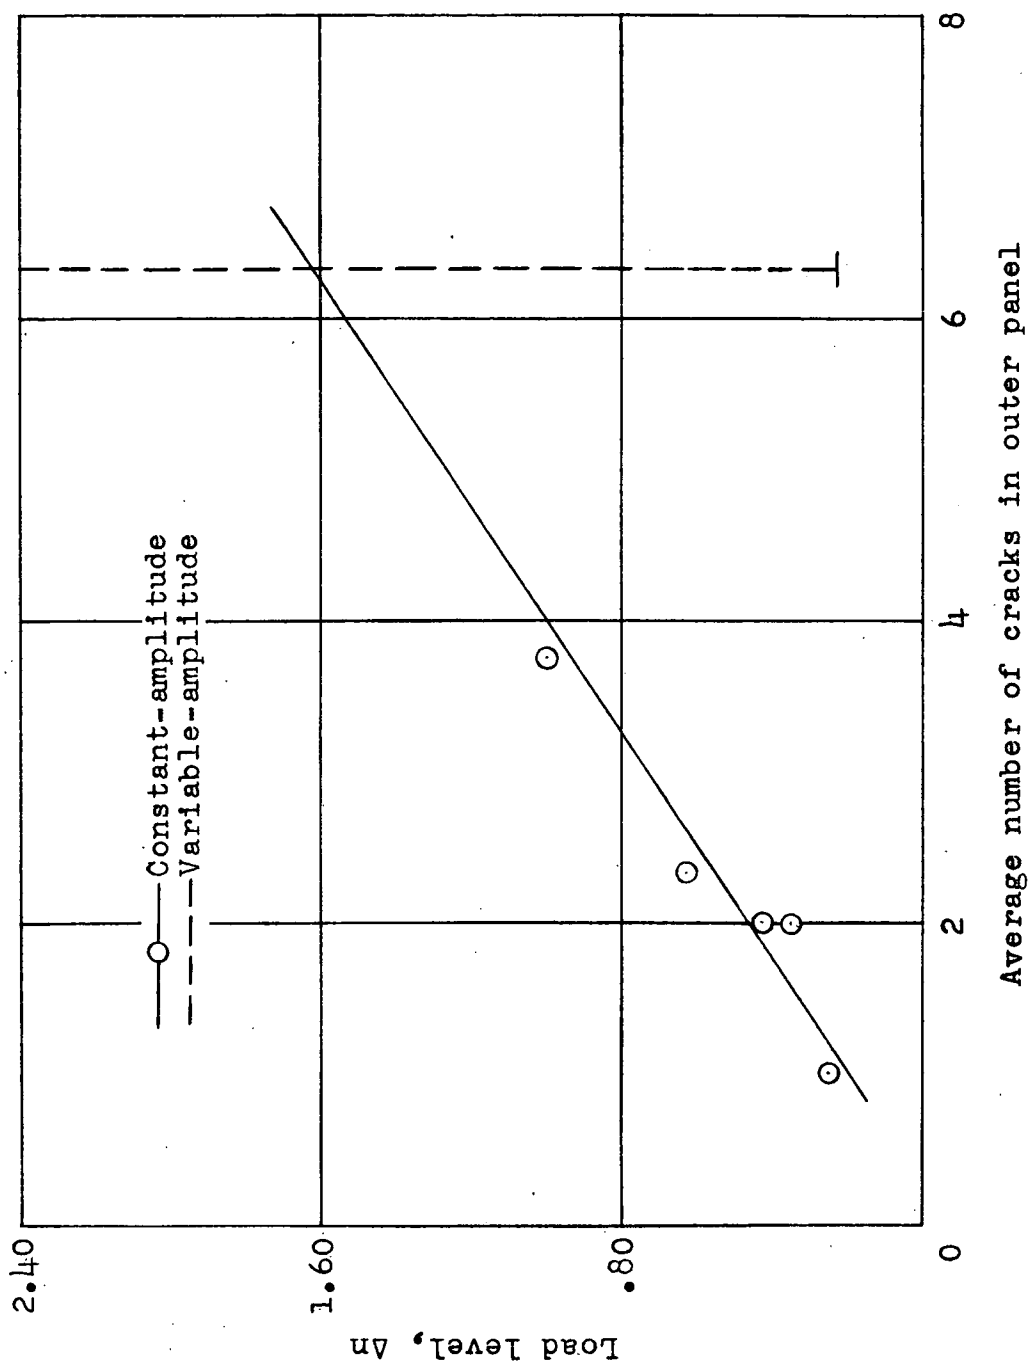
Figure 10.- Frequency of occurrence of cracks for constant-amplitude and variable-amplitude tests.

The average number of cracks per panel was also compared with the results for the constant-amplitude tests. The data from reference 1, shown in figure 10, indicate that the number of cracks per panel increased with increasing load level. The number of cracks per panel during the variable-amplitude tests was larger than for any of the load levels of the constant-amplitude tests. The results of the comparisons indicate that the frequency of occurrence of fatigue cracks during the variable-amplitude tests agrees better with the higher than with the lower load levels of the constant-amplitude tests. They also indicate that any

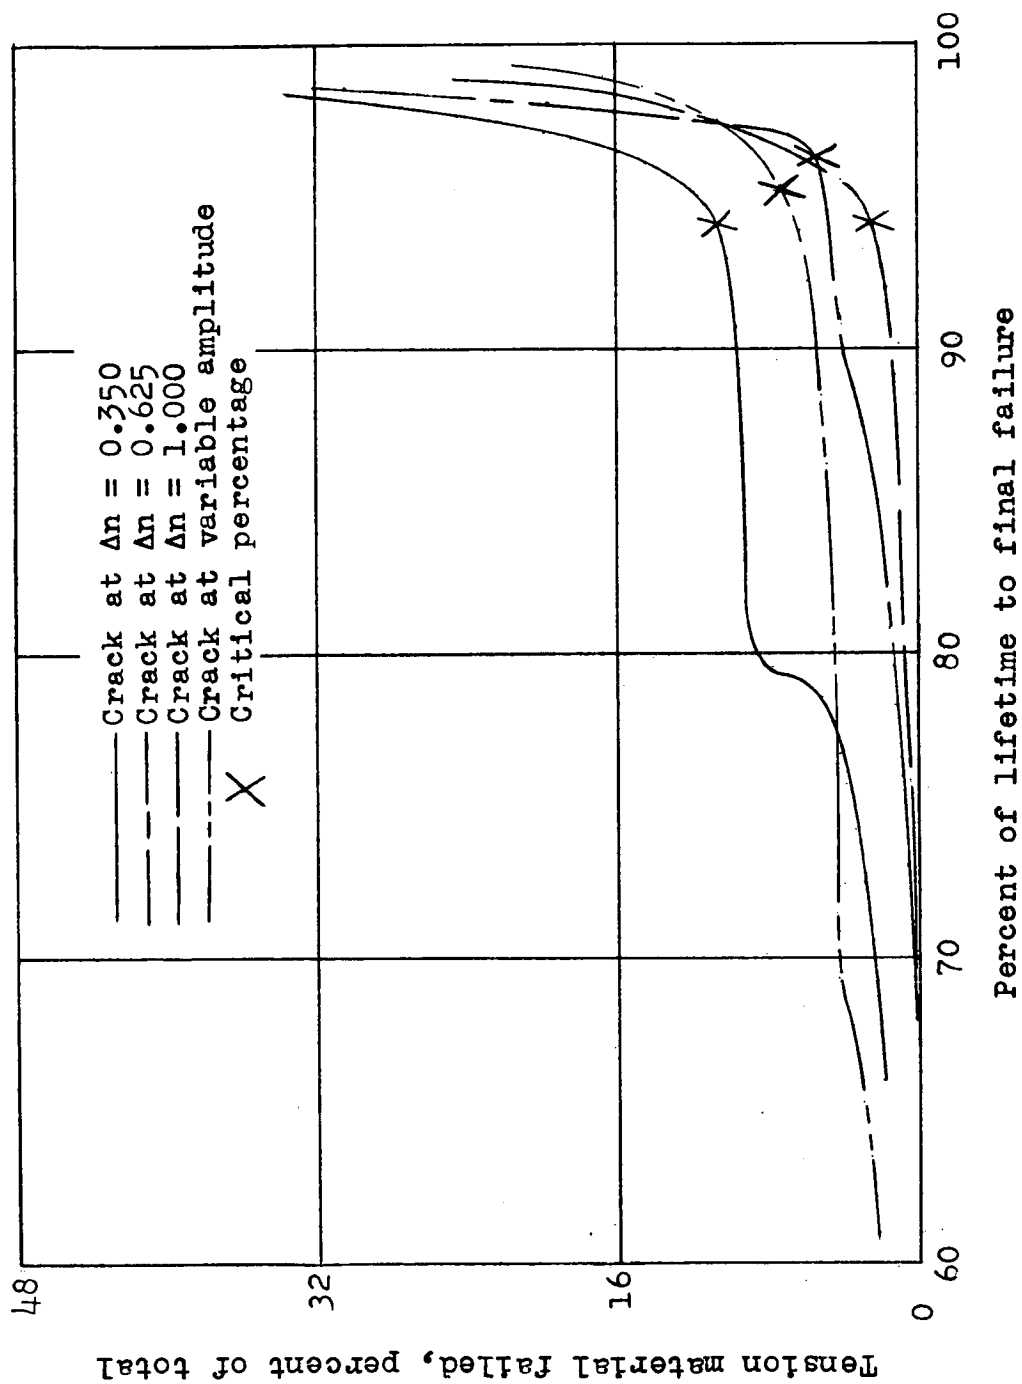
Figure 11.- Typical fatigue-crack propagation.

In figure 11 the propagation curve for a variable-amplitude test is compared with the propagation curves for several load levels of the constant-amplitude tests. The abscissa in this figure is the number of cycles applied, expressed as a percentage of the cycles to complete wing failure as estimated from the propagation curves of figure 6 and reference 2. It can be seen that the propagation curves from both investigations have about the same general shape in that a long period of slow crack growth precedes rapid growth. There are two general types of curves shown in this figure, those that grow slowly up to the critical point with no serious change in slope and one that has a sudden increase in slope at about 80 percent of the lifetime. These two types are associated with the crack location rather than the load level, and both types occurred during the variable-amplitude tests, as shown in figure 6.

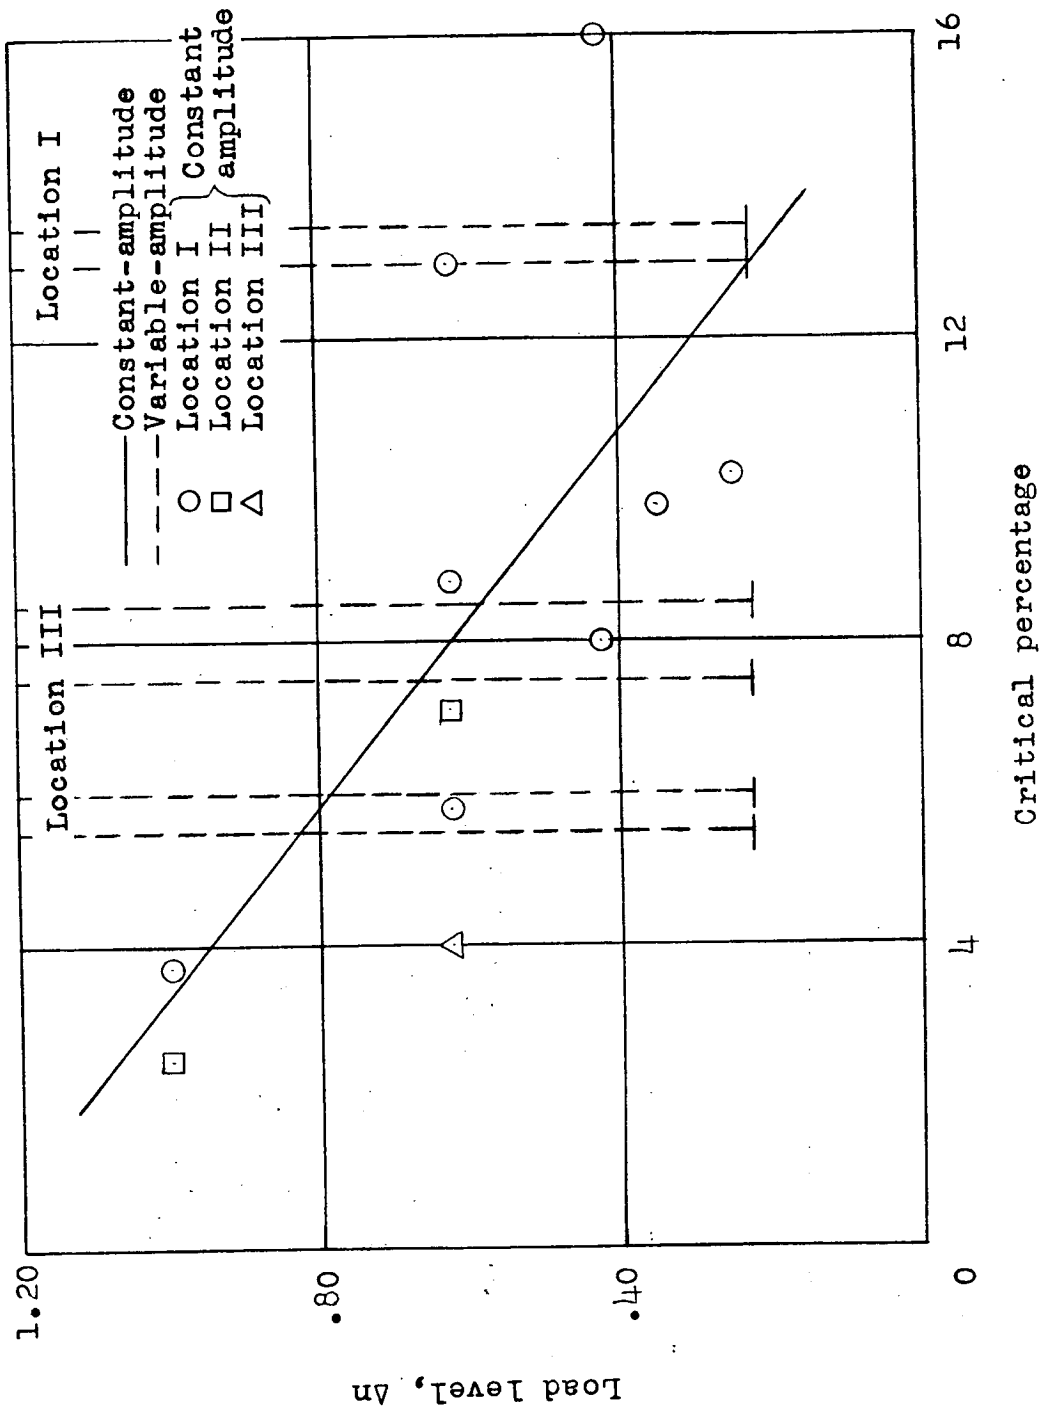
Figure 12.- Tension material failed at critical point.

The results of the constant-amplitude tests indicated that, although there was scatter, the critical percentage varied with the load level. This trend is shown by the solid line in figure 12. Some of the scatter is attributable to the failure location. The critical percentages for the location I failures are generally higher than the critical percentages for the location III failures. Also shown in this figure are the critical percentages from the variable-amplitude data. These also have a

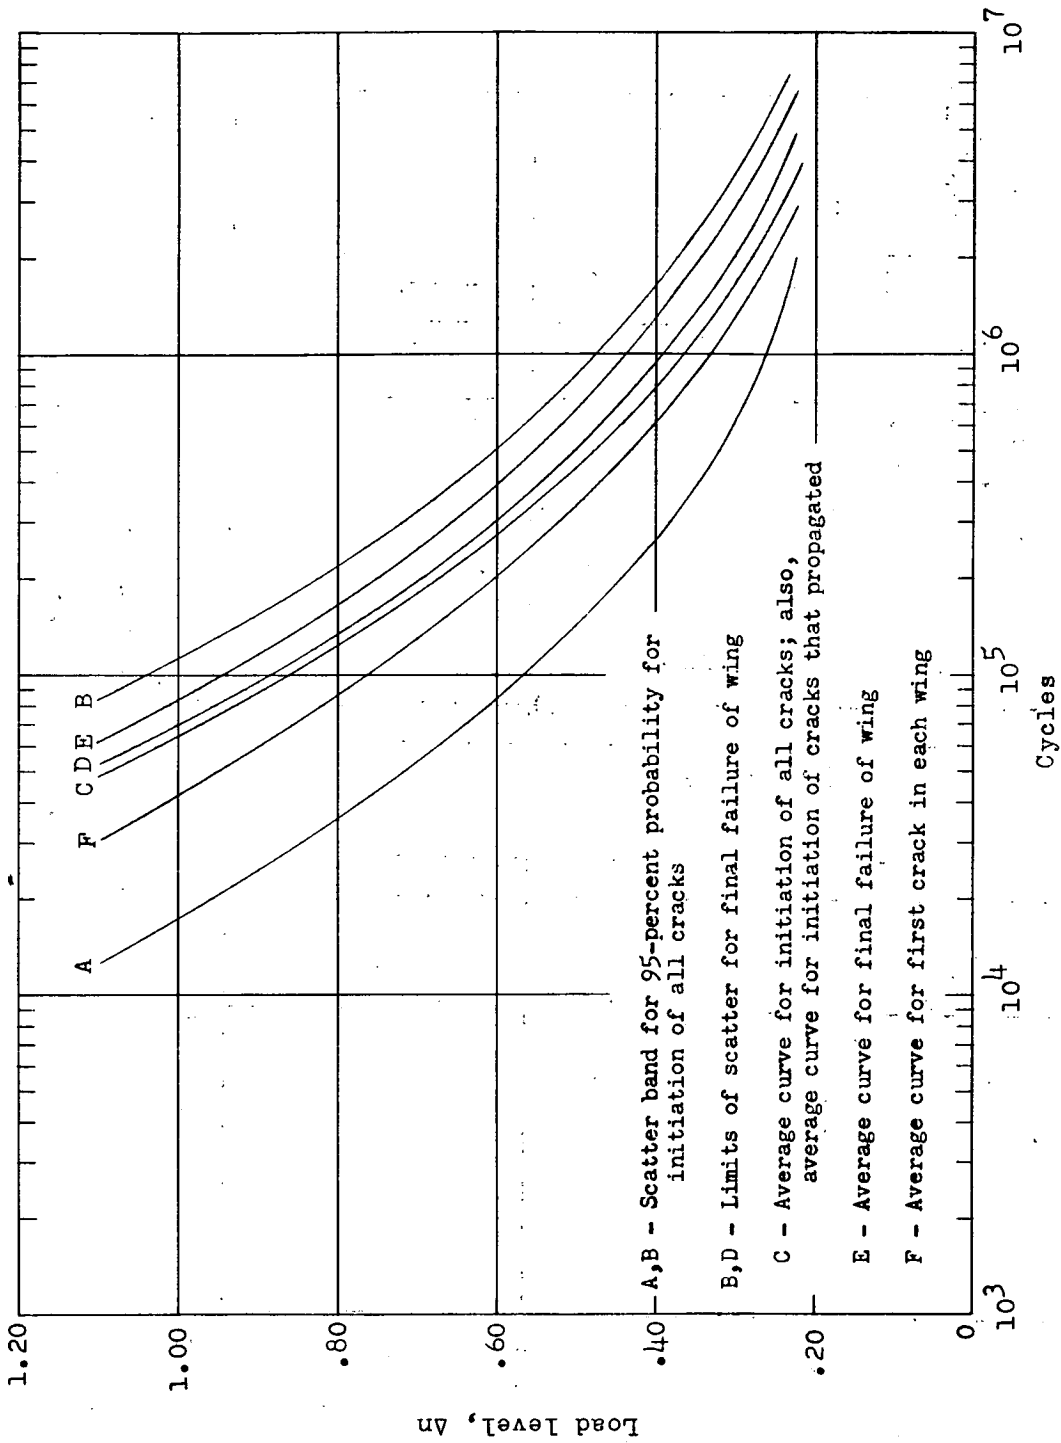
Figure 13.- Load-lifetime diagram from constant-amplitude tests.

A comparison of the lifetime data for the variable-amplitude and constant-amplitude tests involves the use of the load-lifetime relationship. Figure 13 shows the load-lifetime curves from the constant-amplitude tests, with the alternating load level expressed as a function of the number of cycles. These curves, for the most part, were plotted directly from the data of reference 1. They were modified, however, by results given in table 4 for a constant-amplitude test not reported in reference 1. The curves include all the center-section data but they would not be changed appreciably if these data were omitted.
